LOTUS SERVICE BULLETIN

Class	III
Number	1970/11
Type	Europa
Date	1.3.1970.

Title: Radiator Fan Motor.

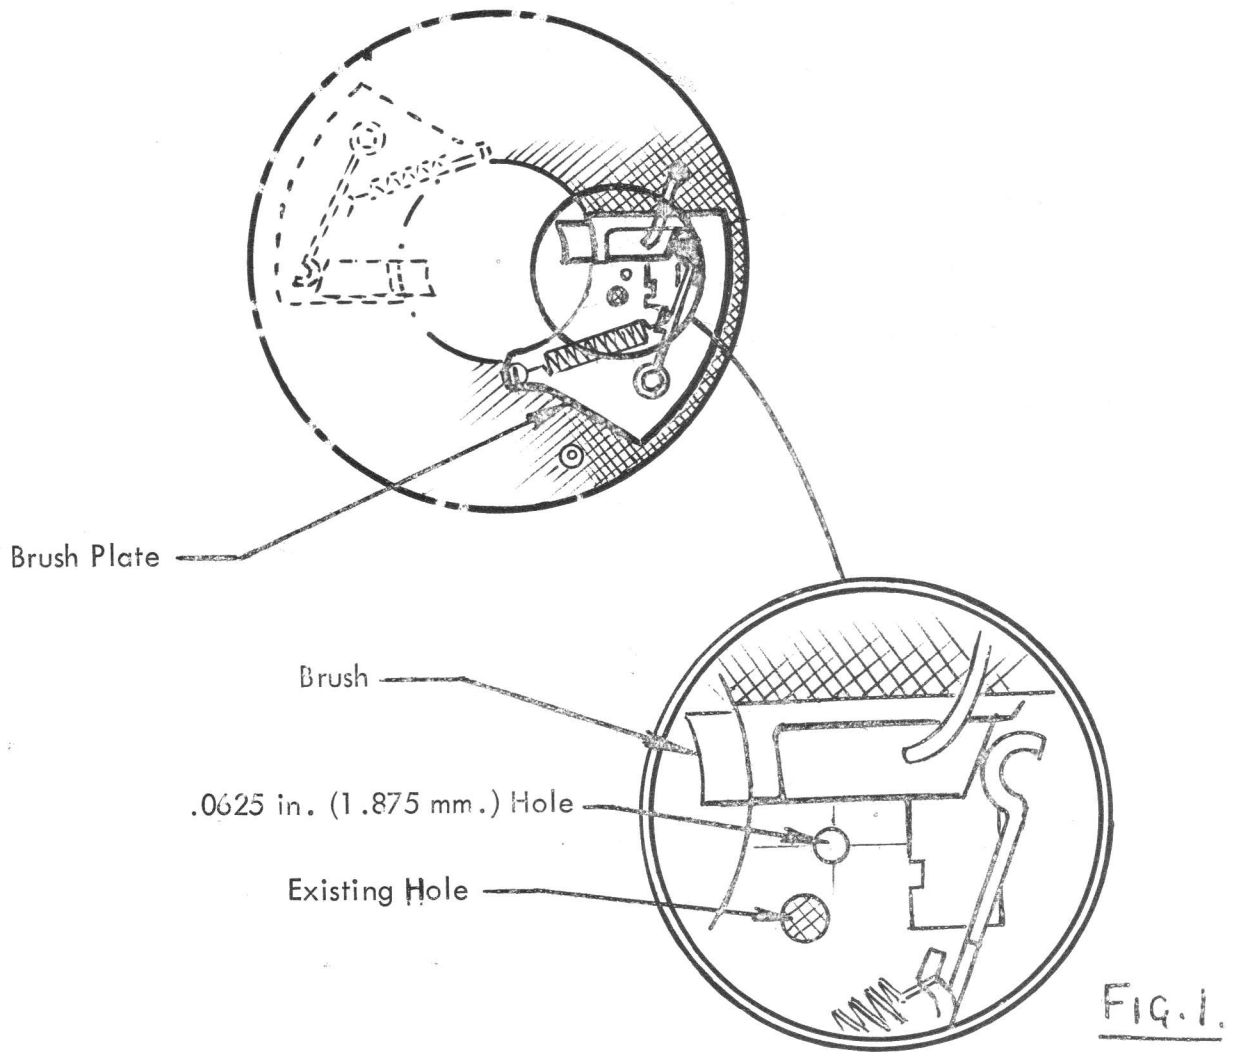
Reason: It has been brought to our attention that in certain cases the Radiator Fan Motor has failed due to the brushes tipping. A simple modification to the brush gear of the motor will eliminate this problem, prolonging the life of the motor and increasing its efficiency.

5. With the brushes in position, scribe a line on each brush plate parallel to the side of each brush and equidistant from the brush and the existing small hole in the brush plate on the open side of the brush guide. (Fig.1).

6. Lift the brushes clear of their seating and drill a .0625 in. (1.875 mm.) hole at the centre point of each scribe mark (Fig.1). The hole should pass into but not through the Tufnol base.

7. Insert a length of .0625 in. (1.875 mm.) brazing wire into each hole and solder into place. Trim the rod flush with the top of the brush guide.
8. Replace the brushes and ensure that the brushes are able to move freely in their guides.
